## Reach 5 – Port Darlington to Port of Newcastle

### Local Conditions

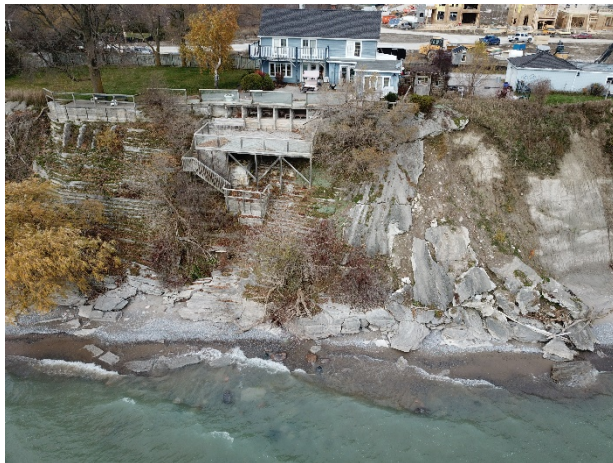
*Eroding Bluffs and Failed Shore Protection East of Port Darlington*

- Immediately east of Port Darlington East Beach there are a number of properties sitting atop a high, rapidly eroding bluff. Some properties feature shore protection of varying quality and condition, while others are unprotected and continue to erode. These properties are at high risk due to their proximity to the bluff crust.

- Implement a sediment bypassing program from the Port Darlington west fillet beach to nourish Port Darlington East Beach Park.
- A long-term community scale solution is required for Port Darlington East Beach community to reduce erosion and flood hazards, such as protection or retreat. For example, a long-term voluntary land acquisition program for lands subject to acute hazards could be implemented to return the shore lands to public open space.

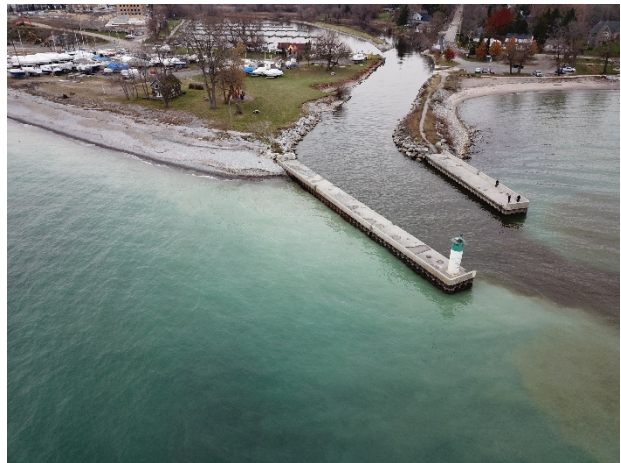
*Cobble Fillet Beach and Jetties at Port of Newcastle*

- The jetties at Graham Creek (Port of Newcastle) are composite gravity structures and are both in moderate condition. The root of both structures is comprised of native fill material with a thin layer of minimal rock protection. These areas have suffered significant damage during the high-water periods in 2017 and 2019 and have nearly breached, particularly on the east side at Bond Head Parkette. These structures should be repaired and upgraded to prevent the propagation of waves and sediment into Graham Creek.

- Deposition occurs primarily in the fillet beach to the west of the Graham Creek jetties, as is evident by the significant offset in shoreline position from the west side to the east (~140 m).

- Root of jetties at Graham Creek require significant repairs/upgrades.
- Implement a sediment bypassing program for the west fillet beach at Port of Newcastle to nourish the eroding east beach (Bond Head Parkette, Boulton Street).
