## Reach 6 – Bond Head to Port Hope West Beach

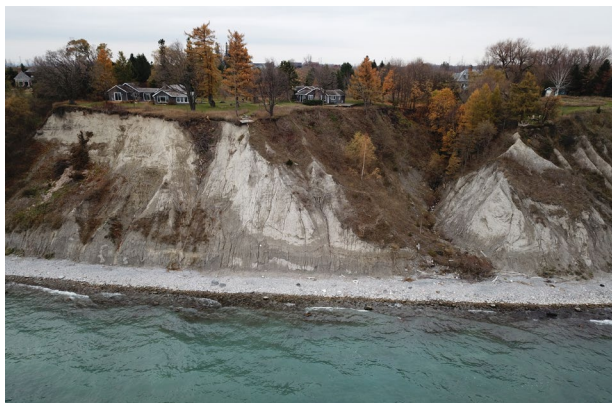
*Eroding Bluffs at Bond Head*

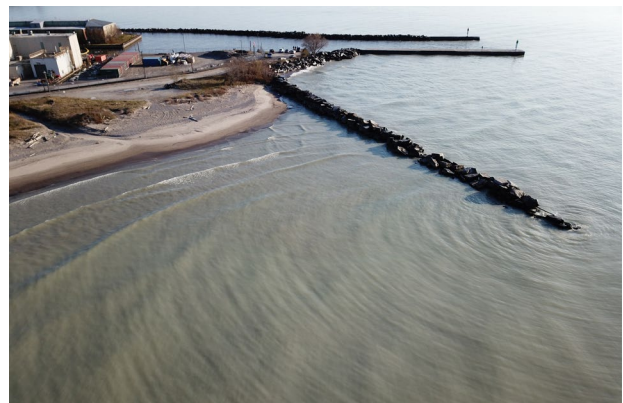
*Port Hope West Beach and Jetties*
