Reach 8 – Cobourg Harbour to Ogden Point

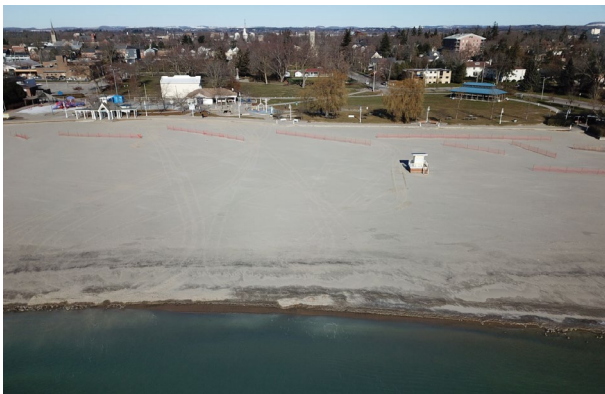
Cobourg Harbour East Beach

- The Cobourg East Beach is low lying and vulnerable to high lake levels, as 2019 demonstrated.
- Sedimentation in the Cobourg Harbour entrance is a navigation risk but managed with maintenance dredging.
- Properties east of Cobourg are vulnerable to high lake levels (protected by bedrock shelf at low to average levels).
- Buildings and parking lots east of Lucas Point Park are vulnerable to shoreline erosion and gullying due to overland drainage.
- The rail corridor east of Spicer is at the waters edge and very vulnerable to shore erosion.
- Pentecostal Camp and CN Rail Line: lakefront development and buildings impacted by flood and erosion hazards.
- Grafton Shores Subdivision: highly erosive bluff threatens existing development.
- Wicklow Beach Road is very close to the lake.

- Continue with beach nourishment program for east fillet beach and consider construction of an artificial dune and foredune complex to inflate the elevation of the beach.

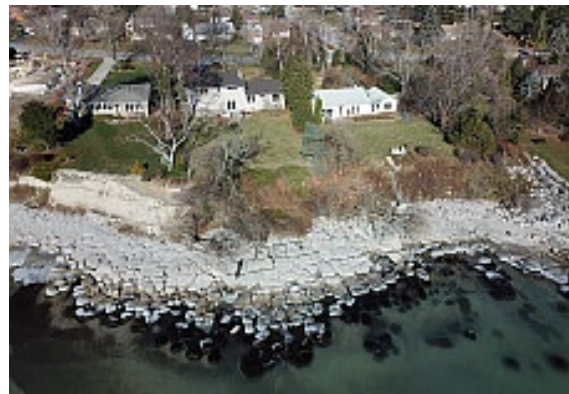
Bedrock Shoreline and Nearshore

- The majority of private properties east of Cobourg remain unprotected, however they benefit from the natural protection provided by an extensive limestone bedrock shelf along the shoreline and in the nearshore.
