Reach 8 – Cobourg Harbour to Ogden Point

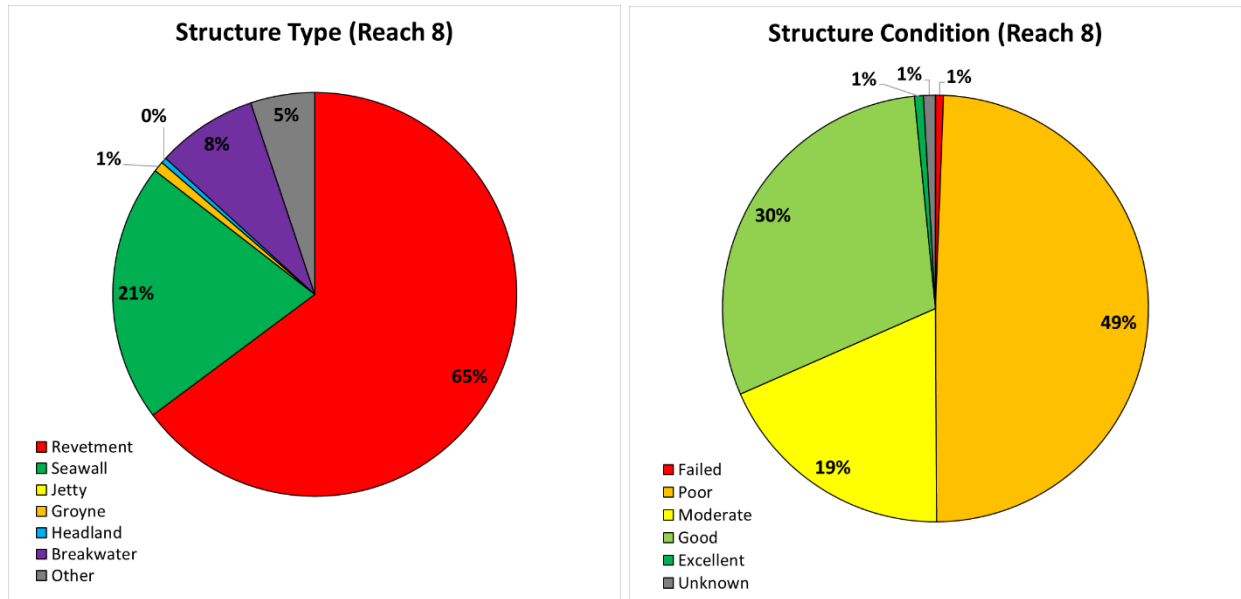
Shoreline Structures

- Private property shore protection east of Cobourg is a combination of older, ad-hoc structures in generally poor condition, and newer, well-engineered structures in generally good condition.

- Shore protection fronting the Pentecostal Camp at Spicer and adjacent CN rail line to the east is generally ad-hoc revetment-type protection built from a combination of stone and scrap concrete. This shore-protection is generally in poor condition and is vulnerable during extreme events.

- Intermittent shore protection throughout the Grafton Shores region is generally well-engineered and in good condition. The majority of properties remain unprotected and have suffered significant erosion in recent years.

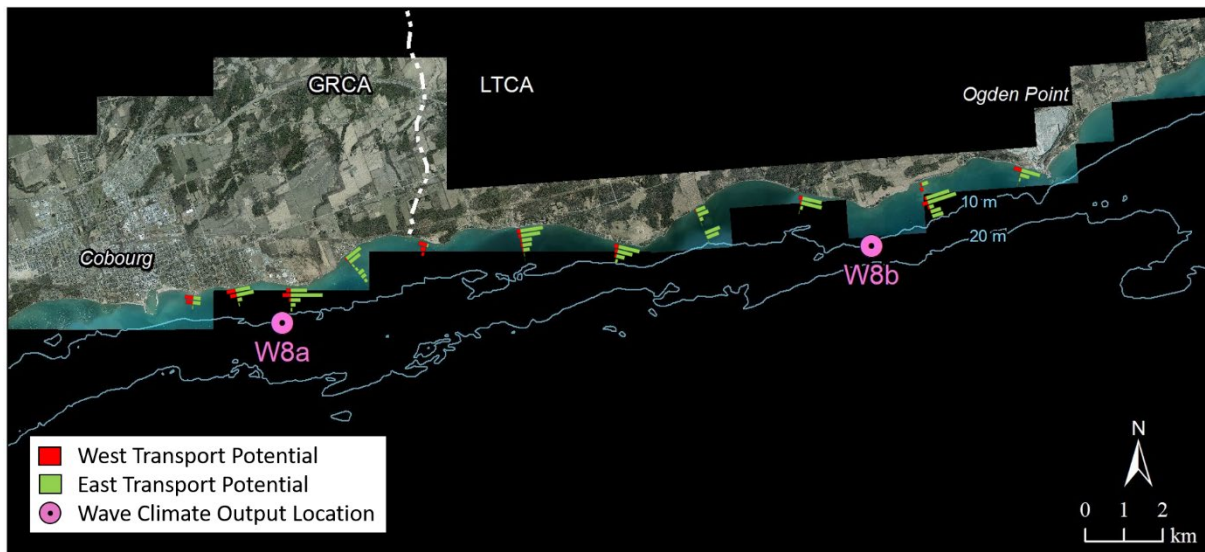
Sediment Supply and Longshore Sediment Transport

- Longshore transport from Spicer to Ogden Point is generally west to east and is partially contained within several sub-cells. These sub-cells exist within small embayments, in which the headlands at either end typically feature significant exposed bedrock in the nearshore (such as at Chub Point). Sub-cells within Reach 8 include:

- Sediment moves from west to east within each sub-cell. In the Grafton Shores region this process is apparent with significant bluff erosion taking place along Lakeshore Road and significant sand and cobble deposits overlying bedrock off of Chub Point.
