Reach 7 – Port Hope to Cobourg

Local Conditions

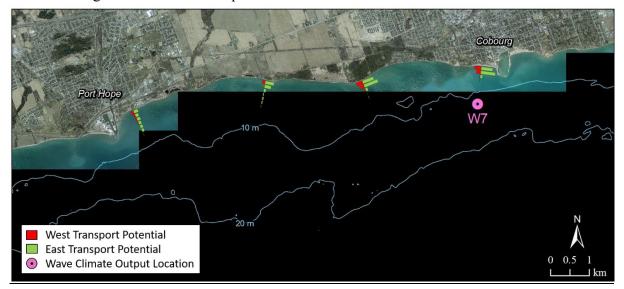
Longshore sediment transport is predominantly from west to east in Reach 7 with a net transport potential of upwards of 100,000 m³/year at several locations throughout the reach.

- The actual transport rates in Reach 7 are likely less than 20% of the potential rate due to a lack of sediment supply and an intermittent exposed bedrock lakebed.
- Sediment supply is mostly limited to local bluff erosion between Port Hope and Cobourg with a small amount of sediment naturally bypassing the jetties at Port Hope.
- Deposition occurs primarily at the Cobourg west fillet beach which features an offset of over 200 m in shoreline position from the west side of Cobourg Harbour to the east.
- Some deposition occurs at the Port Hope east beach during periods of wave action arriving from the southeast quadrant.
